## **BARD AIR CONDITIONING UNIT CONDENSER MOTOR WIRING**

## **DOPPLER METEOROLOGICAL RADAR WSR-88D**

**Data Code: 3118757**  
**Issuance Number: EHB 6-03-00**  
**Issuance Date: 14 April 2000**  
**DoD/NWS Rescission Date: 1 May 2001**

**NWS: EHB-6, Maintenance Note 31**  
**DoD: TO 31P1-4-108-586**  
**FAA: EEM Modification Handbook 6345.1 CHG 18, Chap 15**

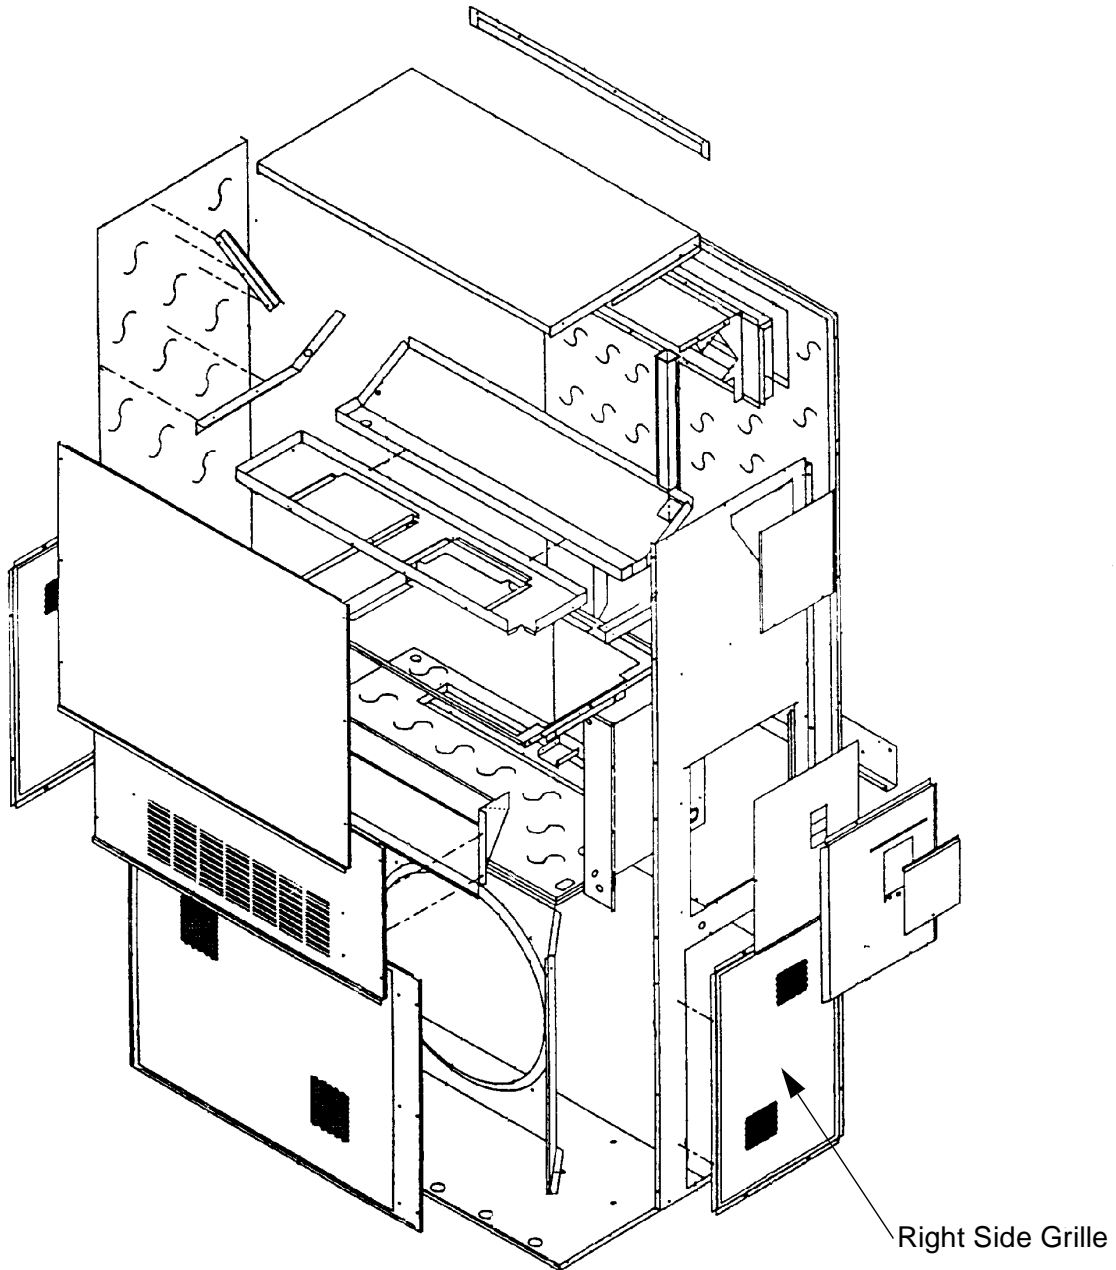
Figure 1. Outside Component Layout

- b. Locate and inspect the fan motor wires for any bare wires or worn spots.
  - c. Using electrical tape, cover each of the bare wires or worn areas with several wraps.

- b. Proceed to the outside of the RDA shelter to the Bard air conditioning units.
2. Perform the following steps to repair and reroute the wires:
  - a. Remove the lower right side grille by removing the (8) eight screws using a 5/16-inch nut driver. (See [Figure 1](#)).
